THE CATASTROPHIC GEOMORPHOLOGICAL PROCESSES IN HUMID TROPICAL AFRICA: A CASE STUDY OF THE RECENT LANDSLIDE DISASTERS IN CAMEROON.

By Appolinaire ZOGNING, Chrétien NGOUANET and Ojuku TIAFACK. Ministry of Scientific Research and Innovation, National Institute of Cartography P.O. Box 157 Yaoundé CAMEROUN email : azogning@yahoo.fr, chngouanet@yahoo.fr, ojuku@justice.com

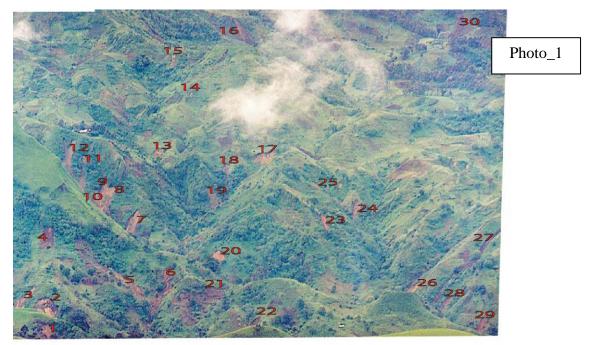
Panoramic view of a section of Magha in the Bamboutos caldera.CL. A. ZOGNINGAbout more than 30 scares of landslides can be observed.CL. A. ZOGNING

This rate of occurrence may be higher if one considers the number of landslides registered per scene. In fact, landslides are becoming more frequent and affect progressively larger areas. This general trend manifested itself in the landslides that hit Limbe in 2001. In this specific case, more than thirty scares could be counted, while in the case of Magha and its neighbourhood in 2003 several hundreds of scares could be counted, stretching over a few square kilometres.

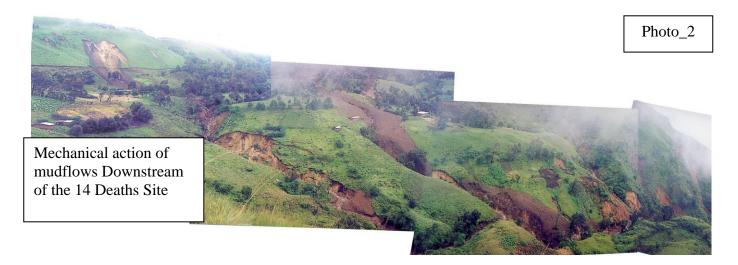
The analysis of the spatial distribution of these combines landslides indicates that a good number of slides result from the sudden erosive action of the mudflow. This is notably the case of the scars located along the flow corridors to which they directly converge. In fact, because of the huge volume of material transported, the rocky composition of debris and the power involved, considerable abrasion is exerted on the flanks of the valley. This results in instantaneous mechanical erosion that cuts away and destabilises the flanks of the valley, leading to subsidence and a series of rock falls and landslides, which increase the amount of material flowing.

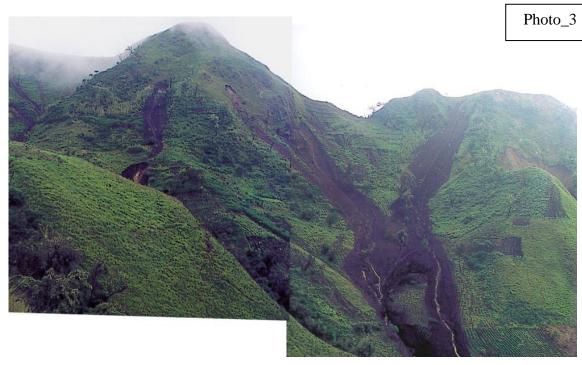
Cl. A. ZOGNING

Unfortunately, in times of prolonged and/or heavy rainfall, the retentive capacity of the ridges may become insufficient, in which case water overspills, flowing downstream, destroying and carrying along, a more or less significant part of the ridge. This may be the starting point of a flow, which can become widespread from up to downstream, degenerating into a real mudflow that clears away everything on its path.
